# AUSTIN, LEWIS & ROGERS, P.A.

- RE: • Duke Energy Carolinas, LLC ("Duke Energy Carolinas") Annual Review of Base Rates for Fuel Costs.  
• Docket Number 2006-3-E.  
• **Filing of Materials Related to Catawba Outage.**

Duke Energy Carolinas' Significant Event Investigation Team- Final Report of August 4, 2006.

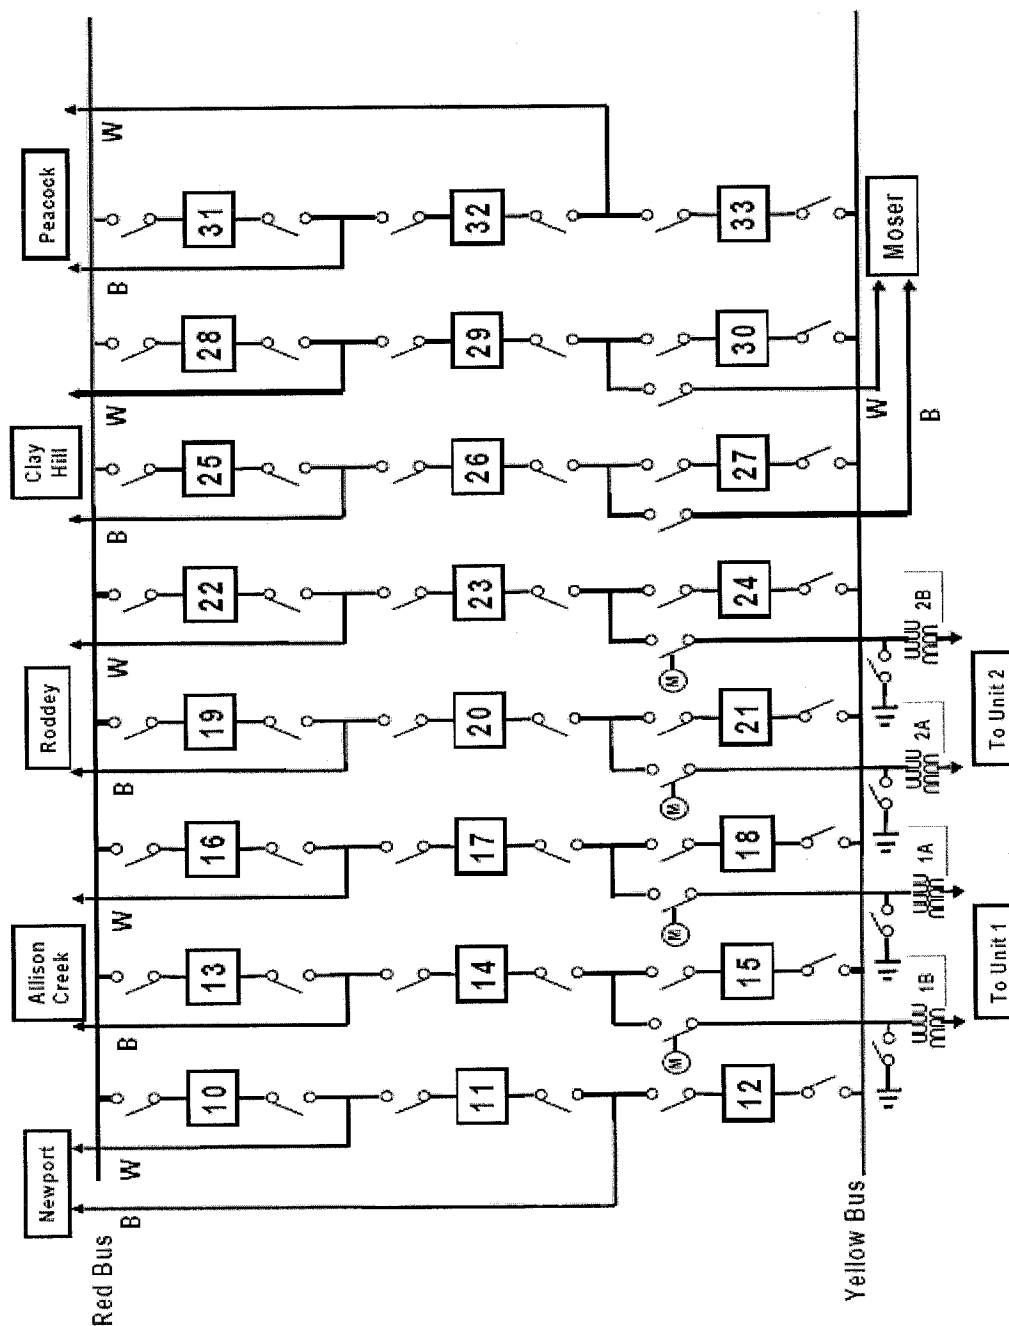
# CATAWBA HIGH VOLTAGE SWITCHYARD SIMPLIFIED DIAGRAM

On May 20, 2006, at 2:01 p.m., an electrical fault in the Catawba 230kV switchyard caused several power circuit breakers (PCB's) to open resulting in a loss of all offsite power (LOOP) and a subsequent reactor trip of both units from 100 percent power. All reactor trip breakers opened as expected and all control rods fully inserted into the core on the two units. Both main turbines tripped upon receipt of the P4 protective signals following the reactor trips. Control room operators responded to the event using normal, abnormal and emergency operating procedures.

With both units at 100% power, all of the breakers shown in the simplified diagram above are in the CLOSED position.
